# **GEARY CORRIDOR BUS RAPID TRANSIT PROJECT**

## **NOISE AND VIBRATION IMPACT REPORT**

**SAN FRANCISCO COUNTY  
TRANSPORTATION AUTHORITY**

**TERRY A. HAYES ASSOCIATES INC.**

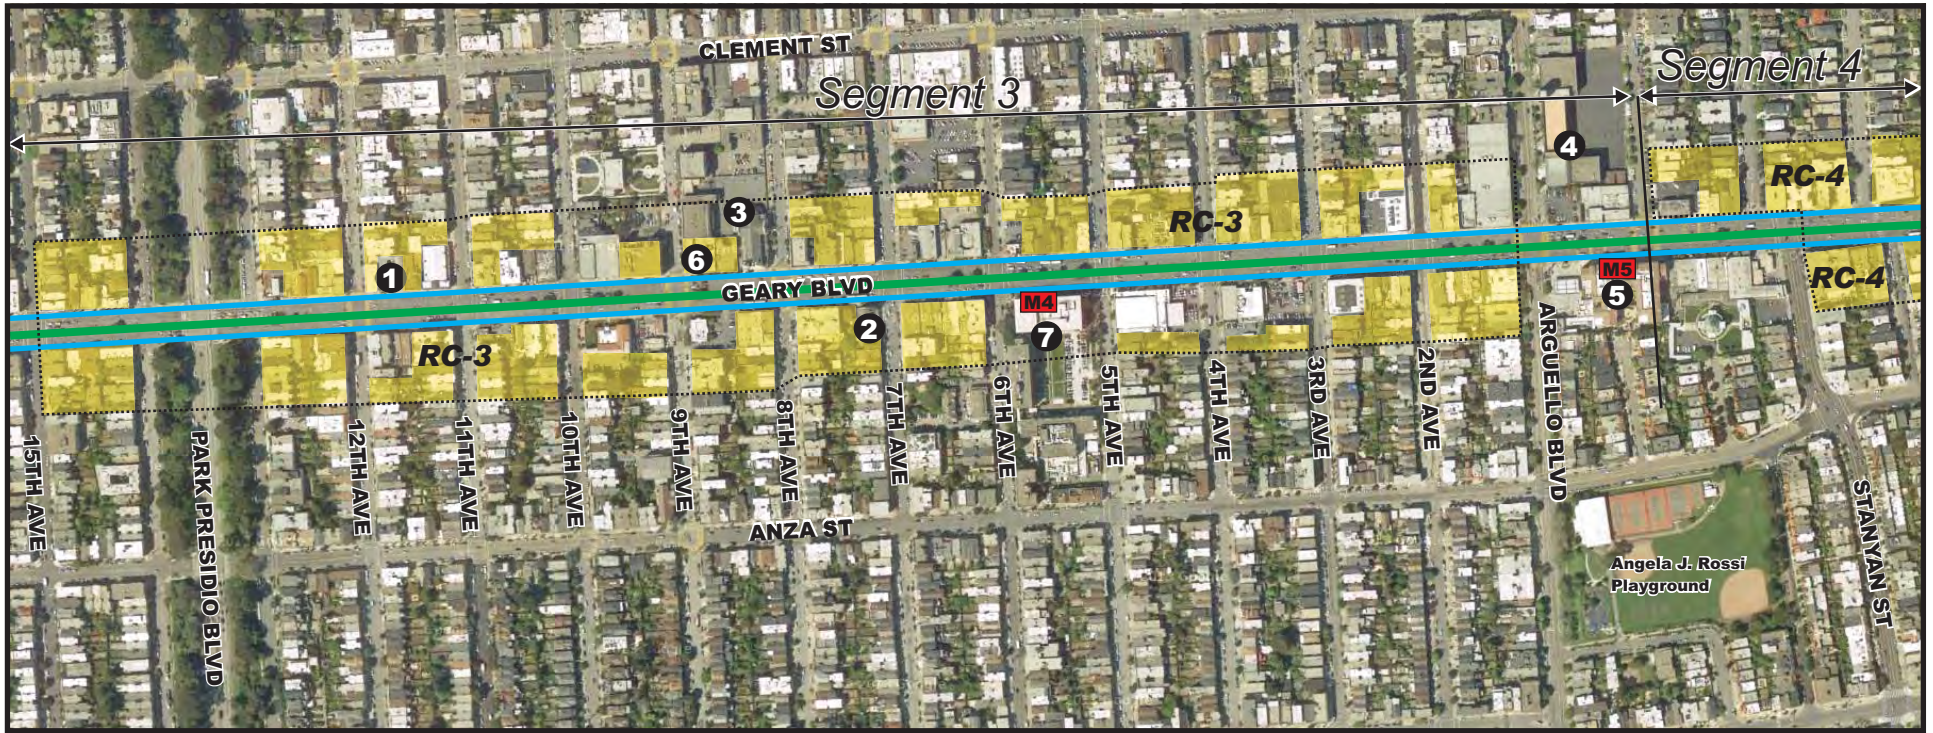
NOISE SENSITIVE RECEPTORS  
 15TH TO COMMONWEALTH AVENUES

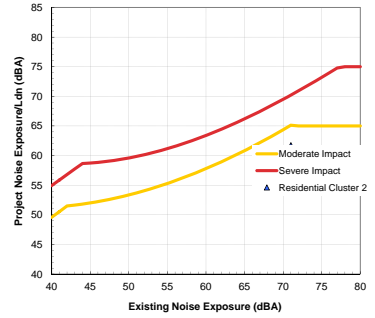
Noise Impact Criteria  
 (FTA Manual, Fig 3-1)

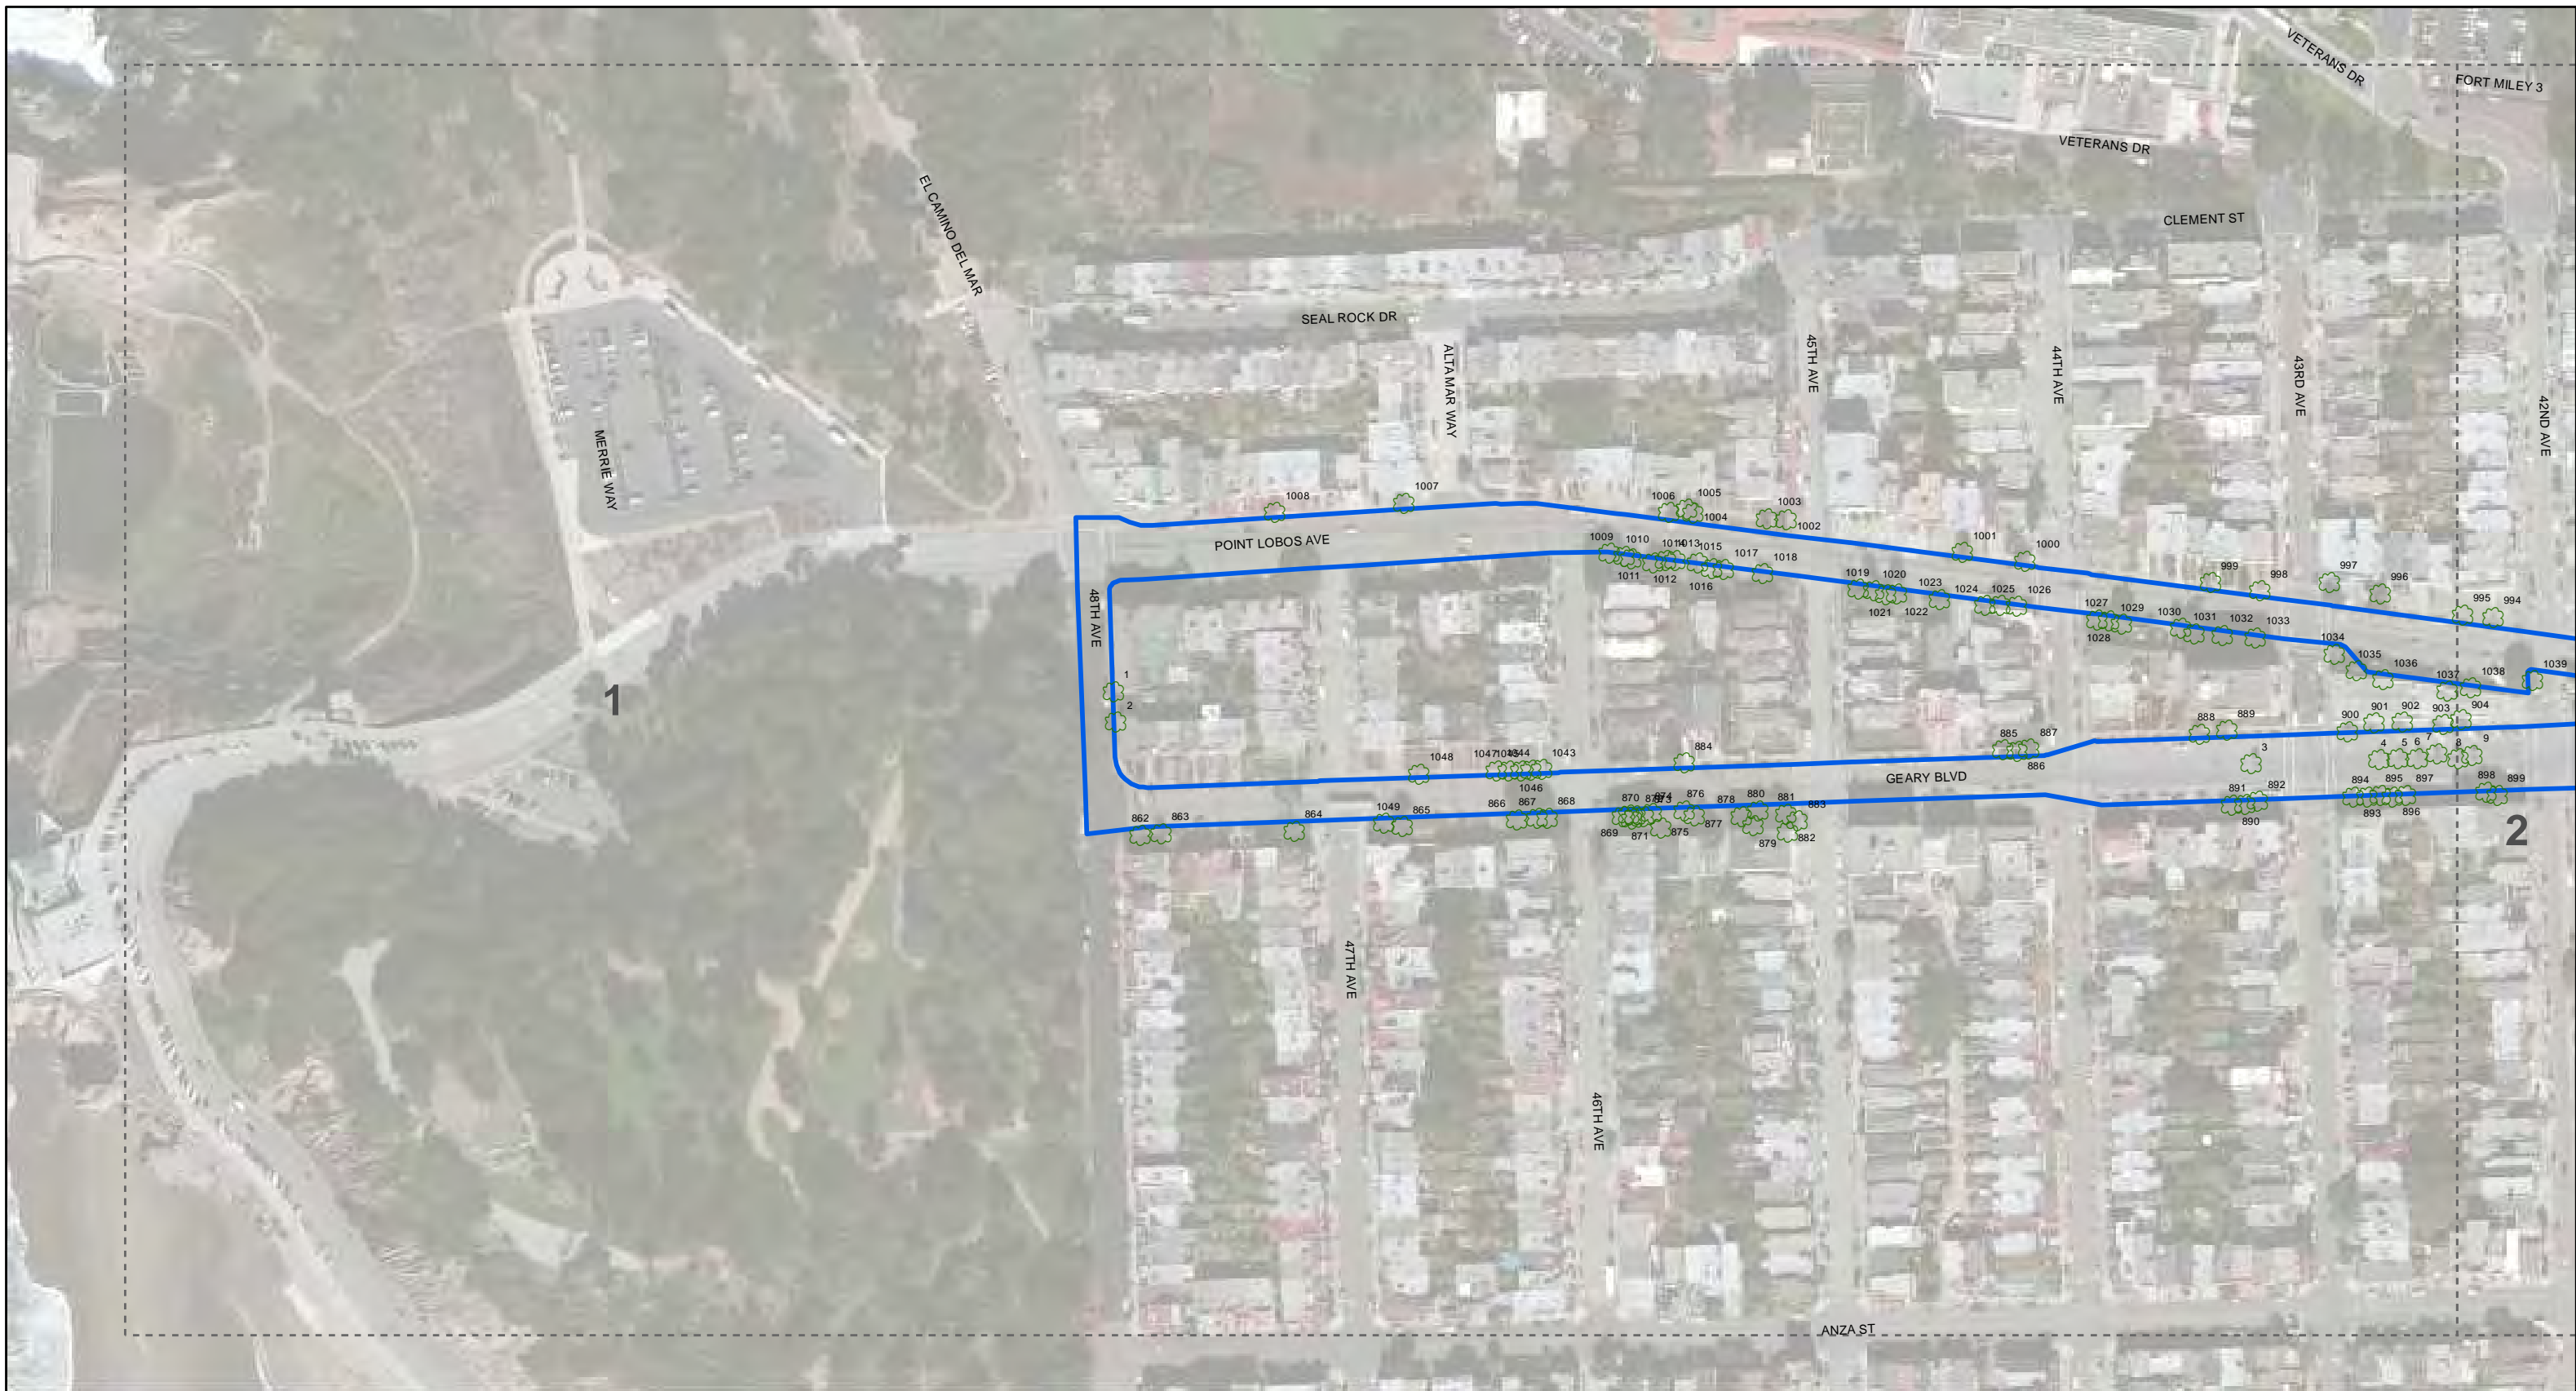
**Geary Bus Rapid Transit Project  
Alternative 2  
Tree Preservation and Removal**

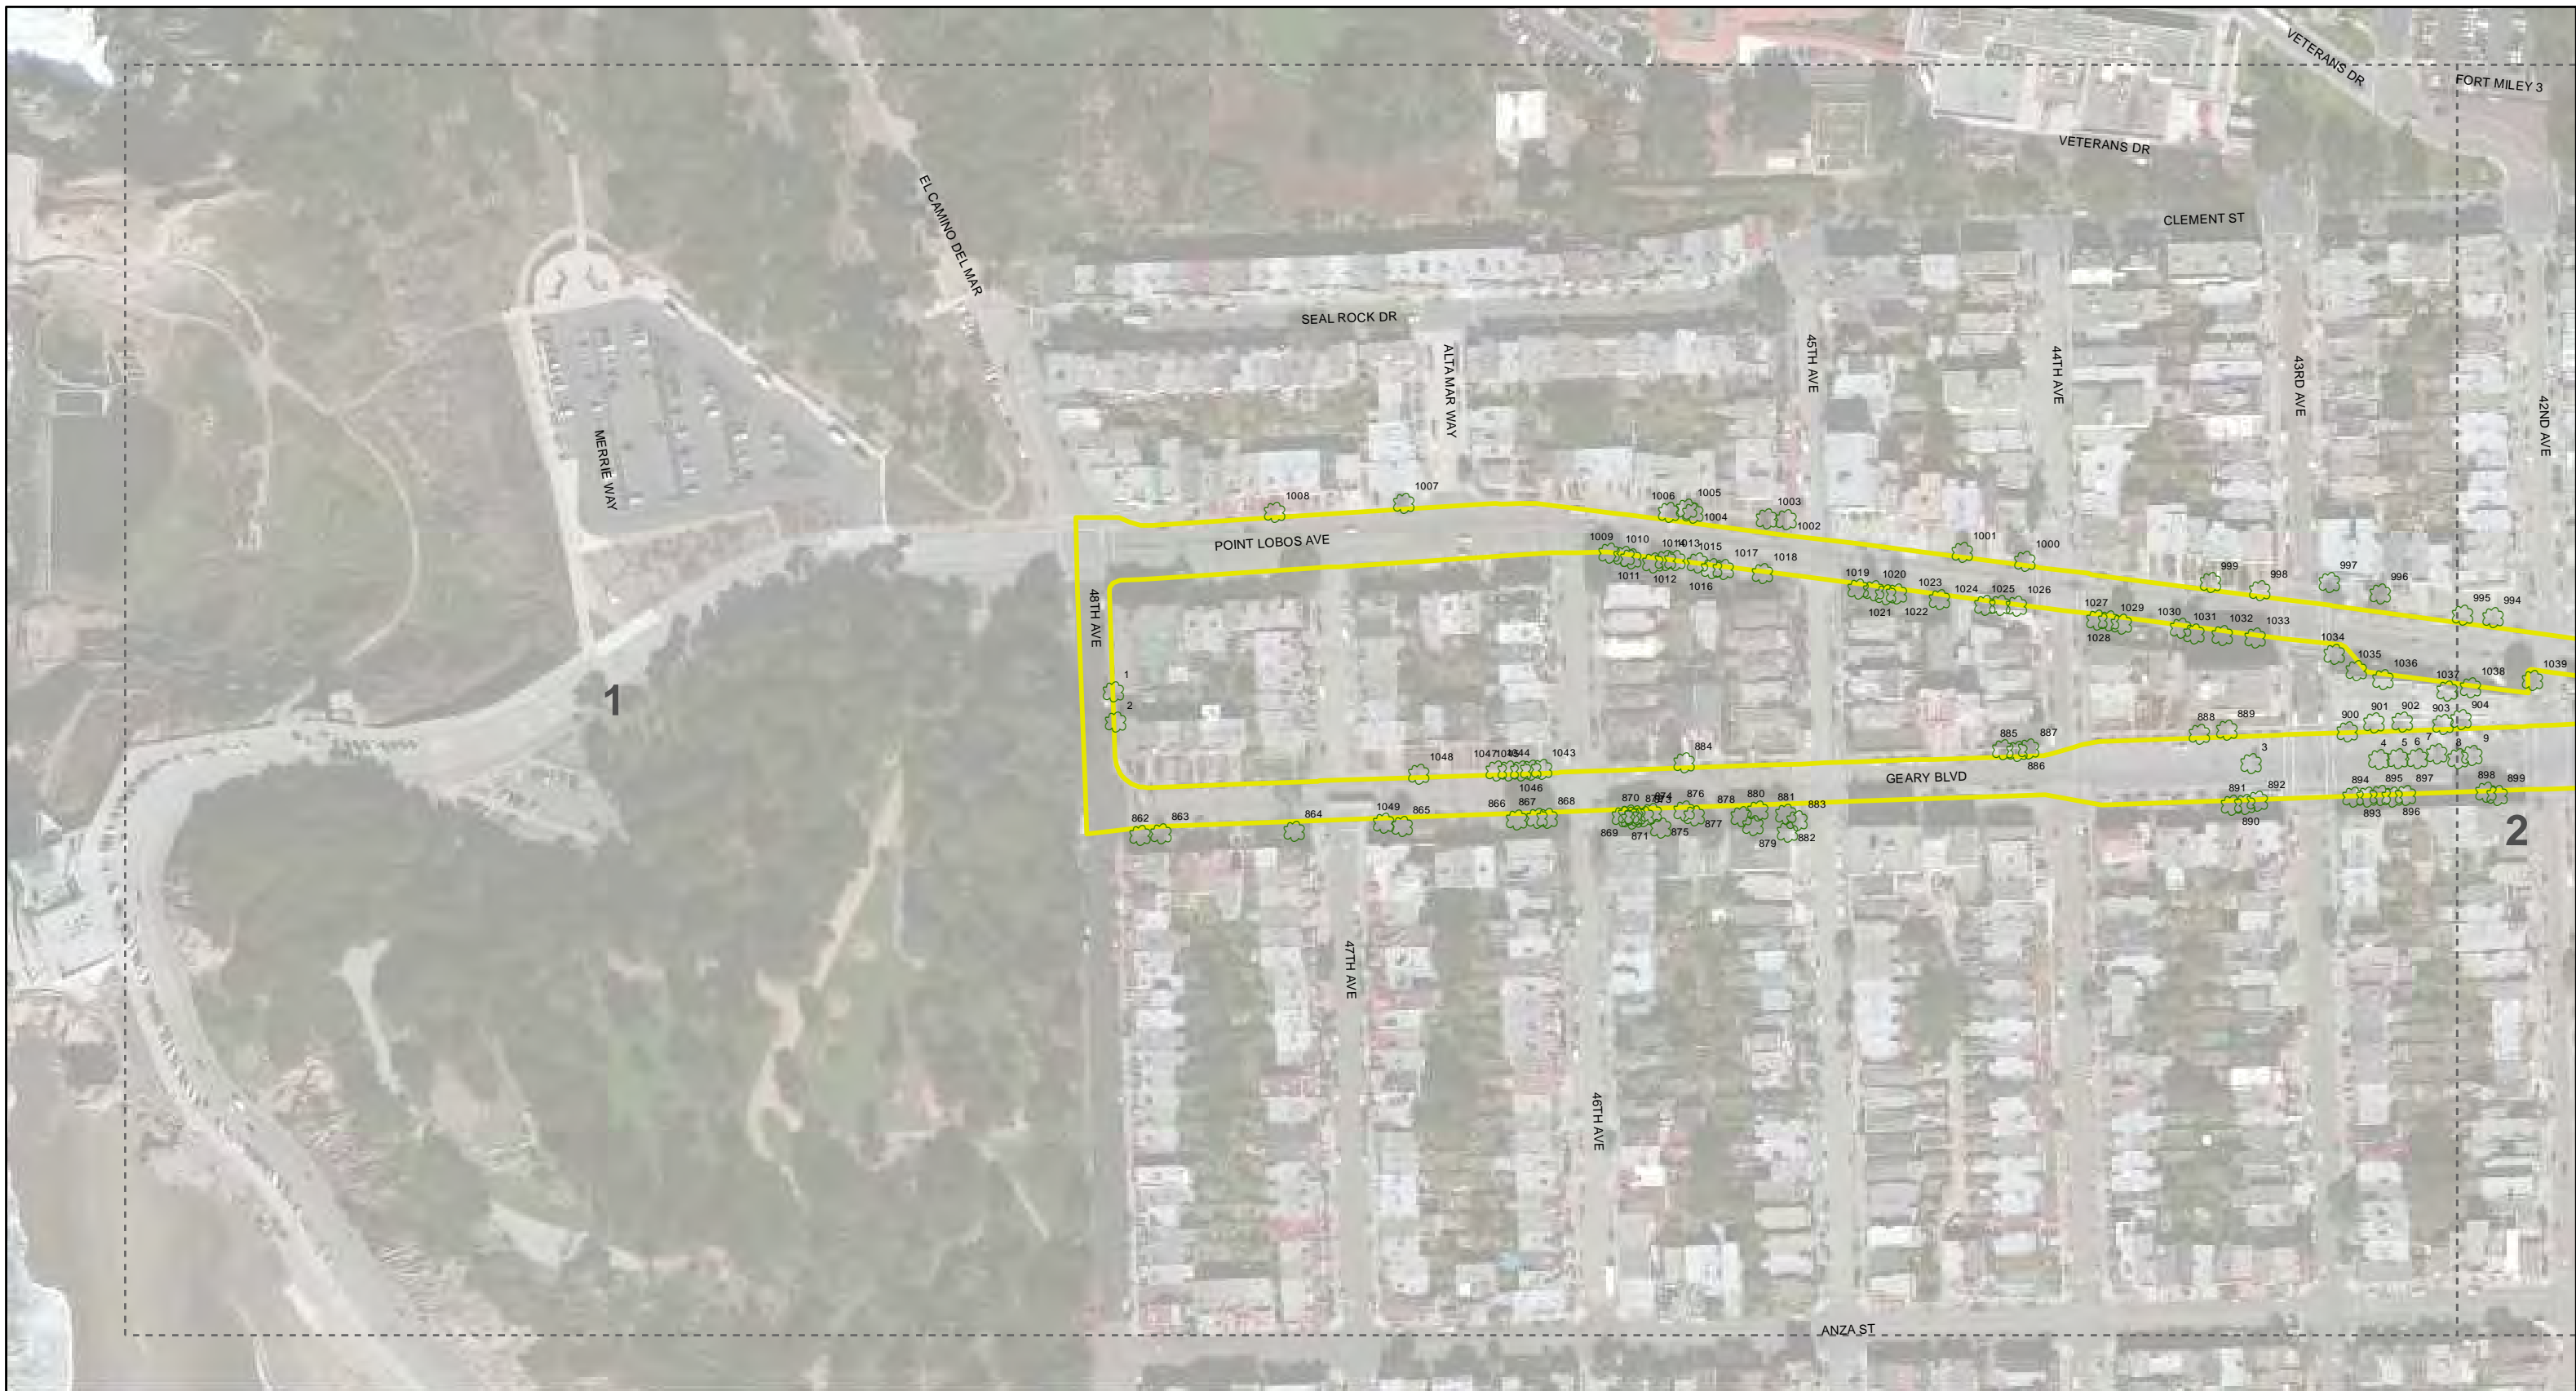
**Geary Bus Rapid Transit Project  
Alternative 3  
Tree Preservation and Removal**

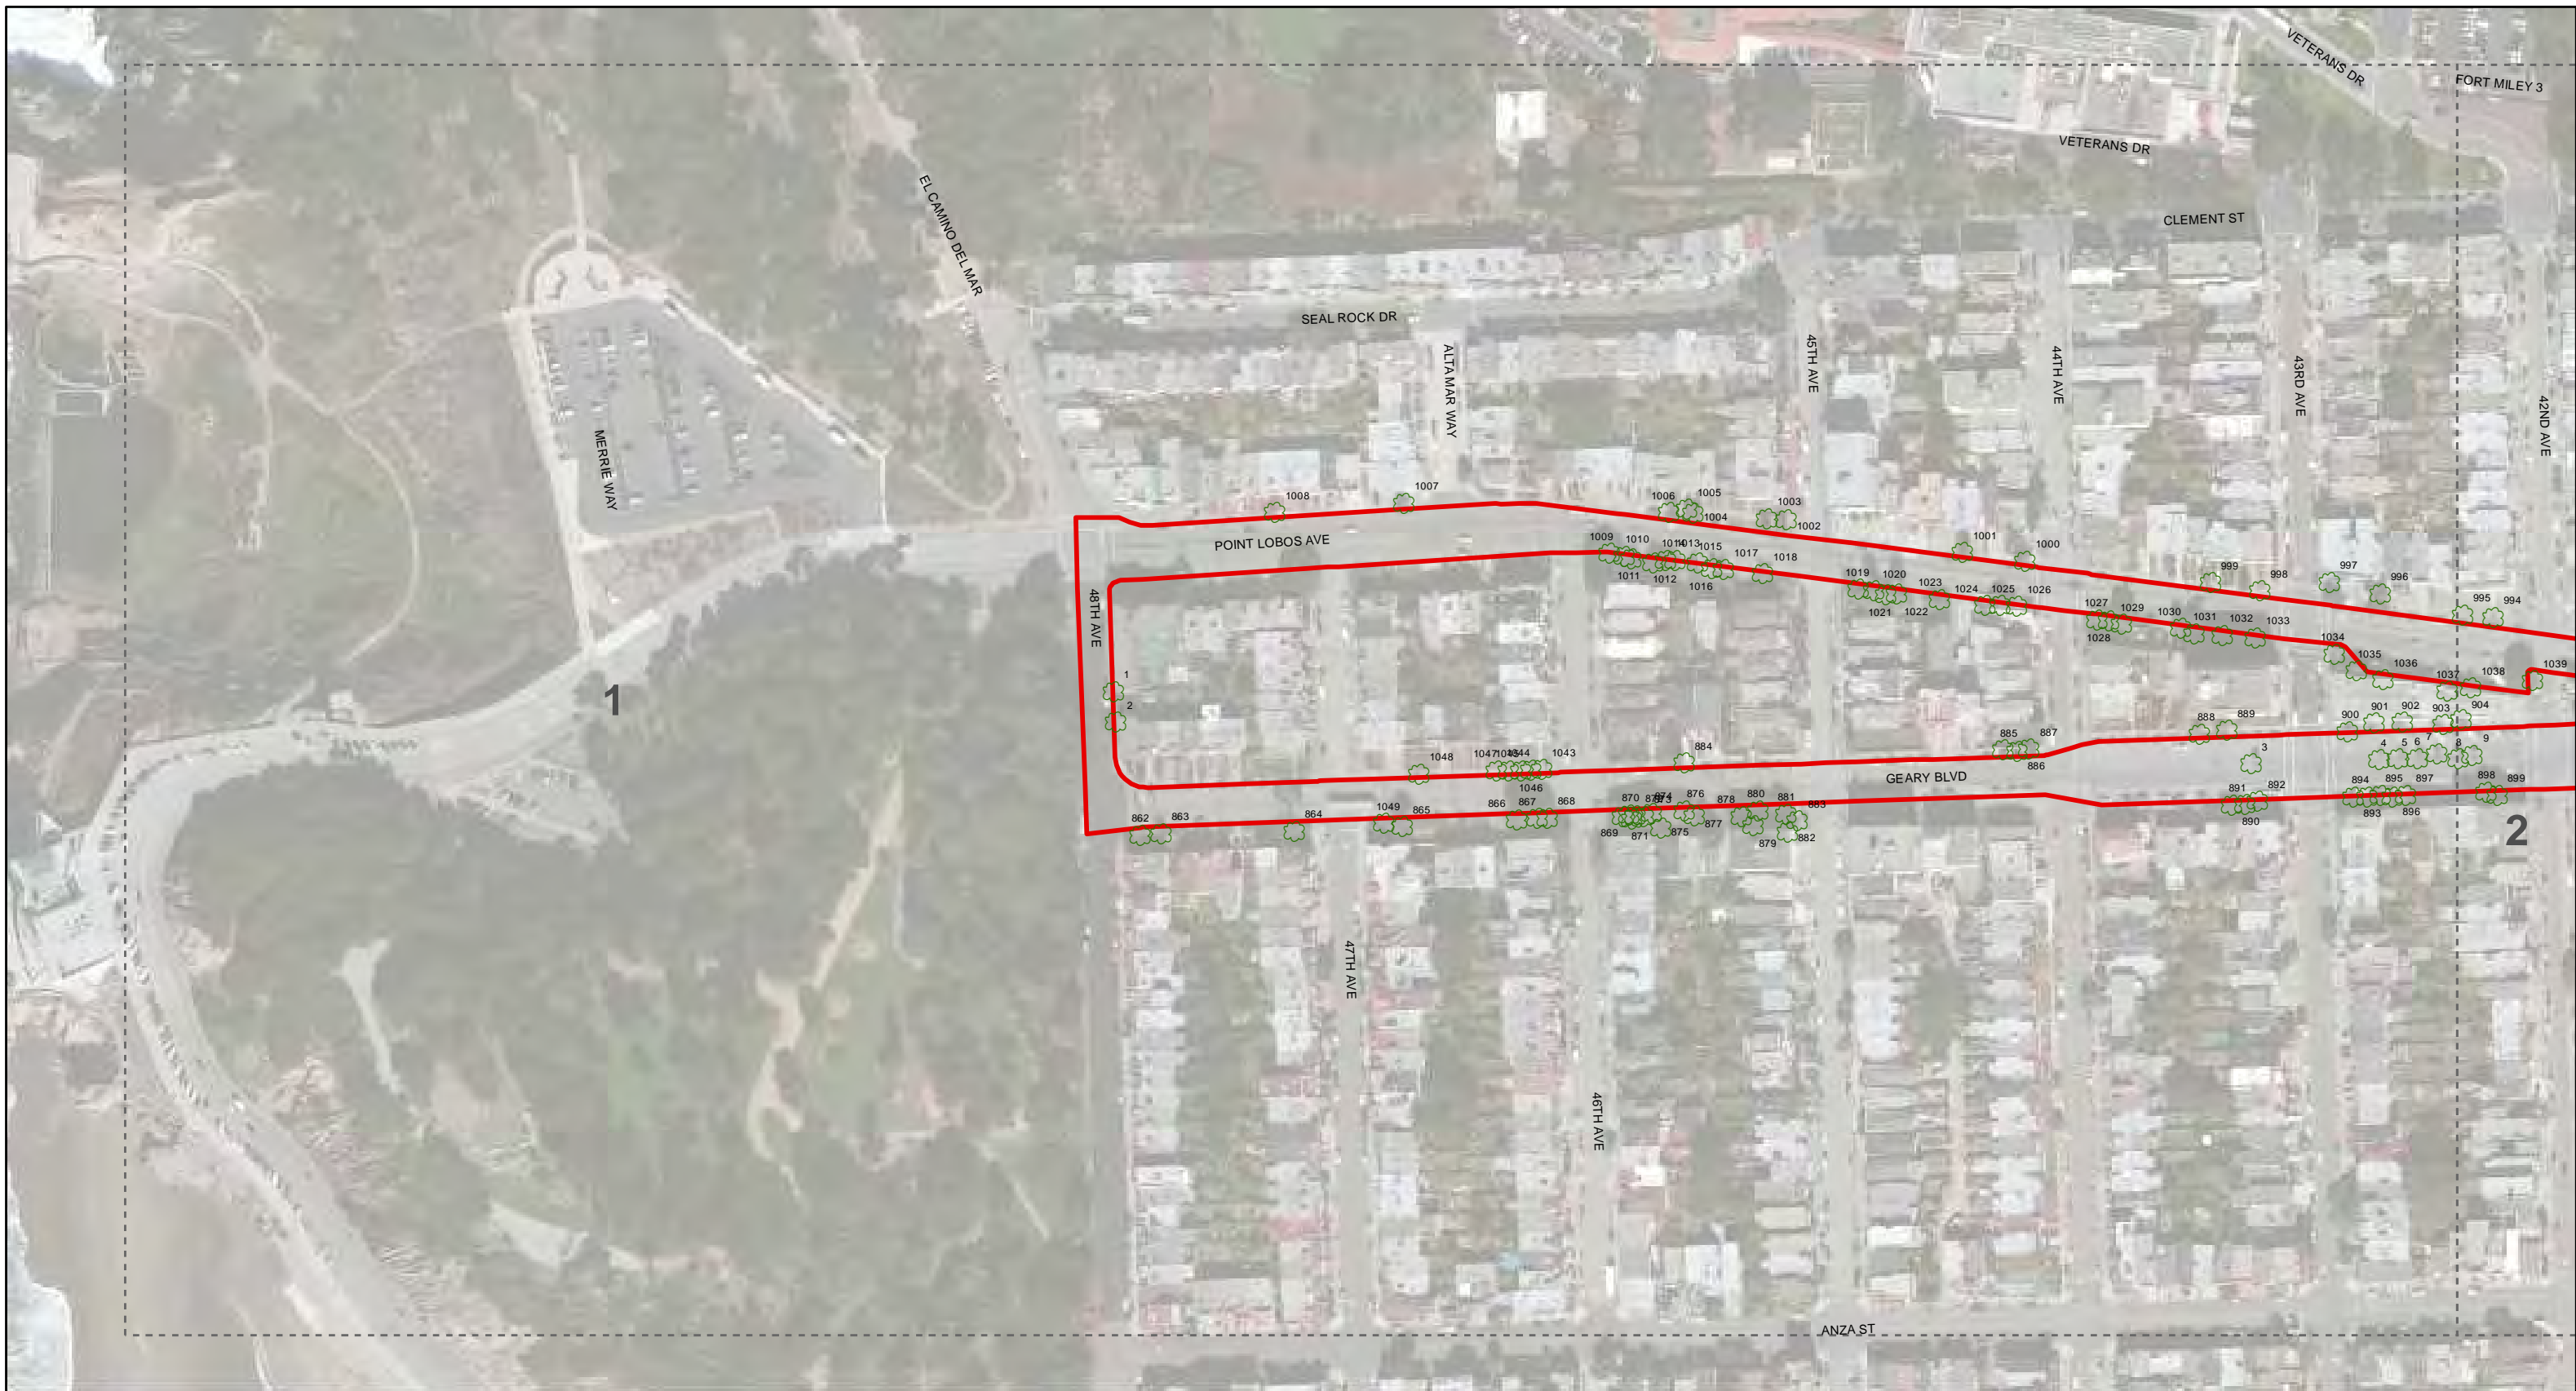
**Geary Bus Rapid Transit Project  
Alternative 3 Consolidated  
Tree Preservation and Removal**
