Update on Temporary Closure of Salesforce Transit Center

March 12, 2019

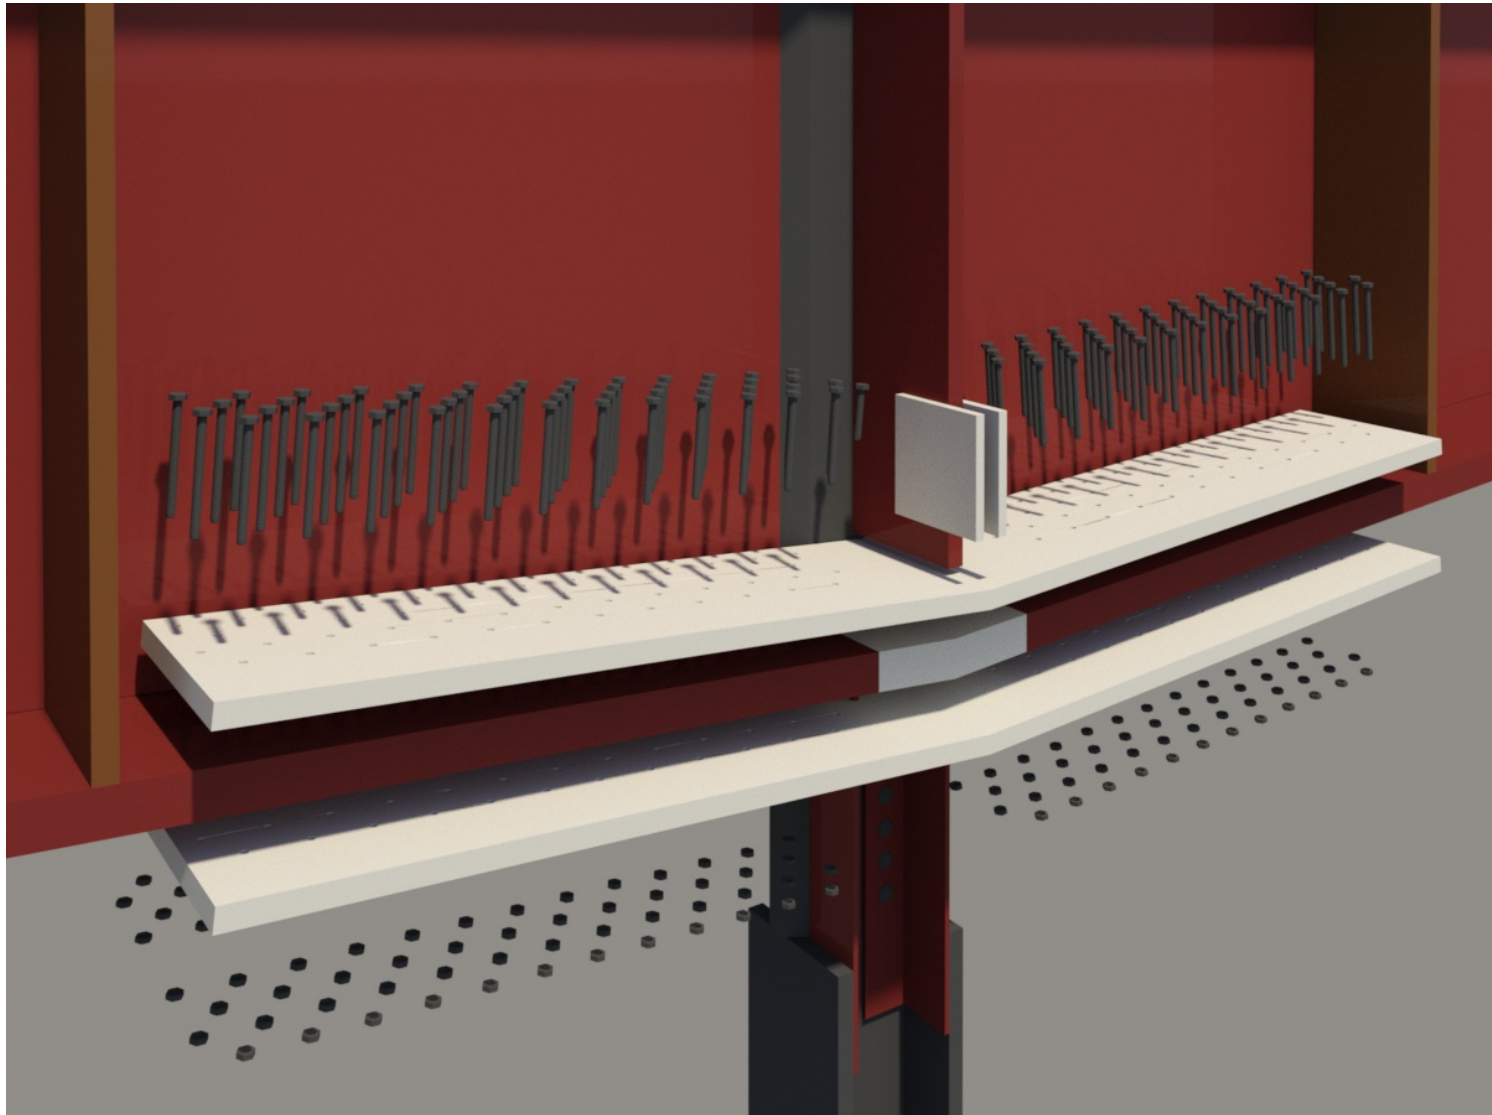
Girder Remediation Detail

This graphic has details specific to Fremont street girders

- ✓ Repair beams on Fremont Street & proactively reinforce similarly designed area at First Street
- ✓ Conduct exhaustive review of facility
- ✓ Fully cooperate with independent review by the Metropolitan Transportation Commission
- ✓ Complete a facility-wide life & safety reinspection program with city and state oversight
- ✓ Open facility & resume transit operations

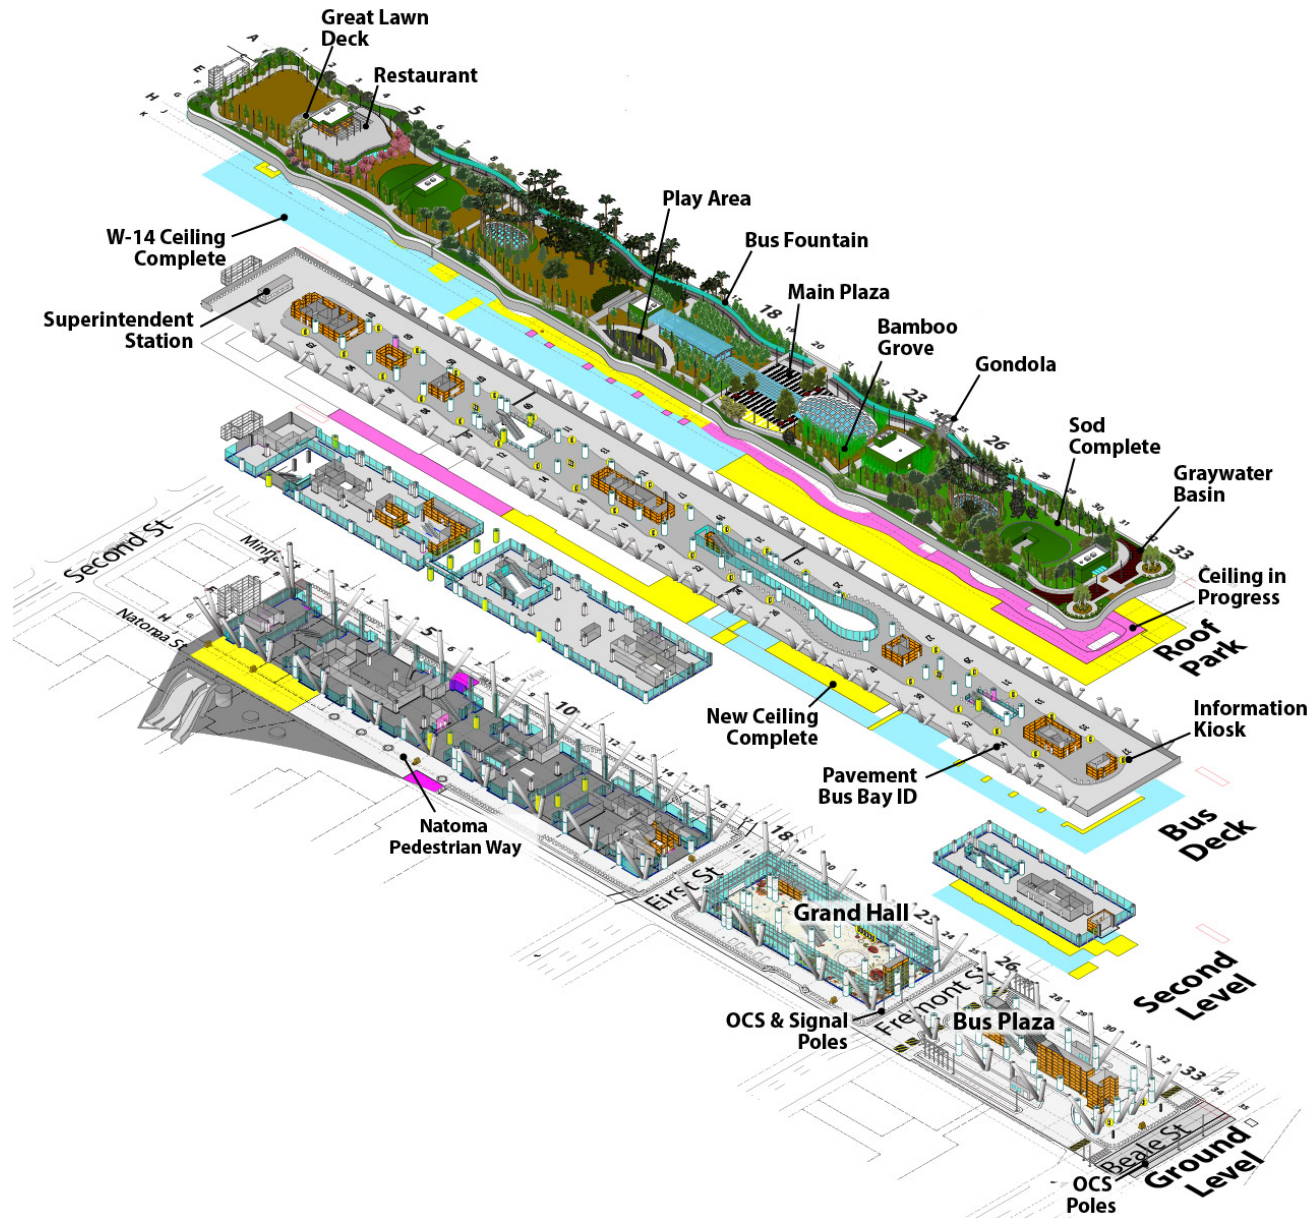
Facility-Wide Validation Framework

- Reaffirm Structural Integrity of Building
- Review Tests & Inspection Records completed in March
- Building Management Systems Commissioning completed in April
- Revalidate Full Fire & Life Safety Systems completed in May
- Re-Occupancy Readiness Strategy

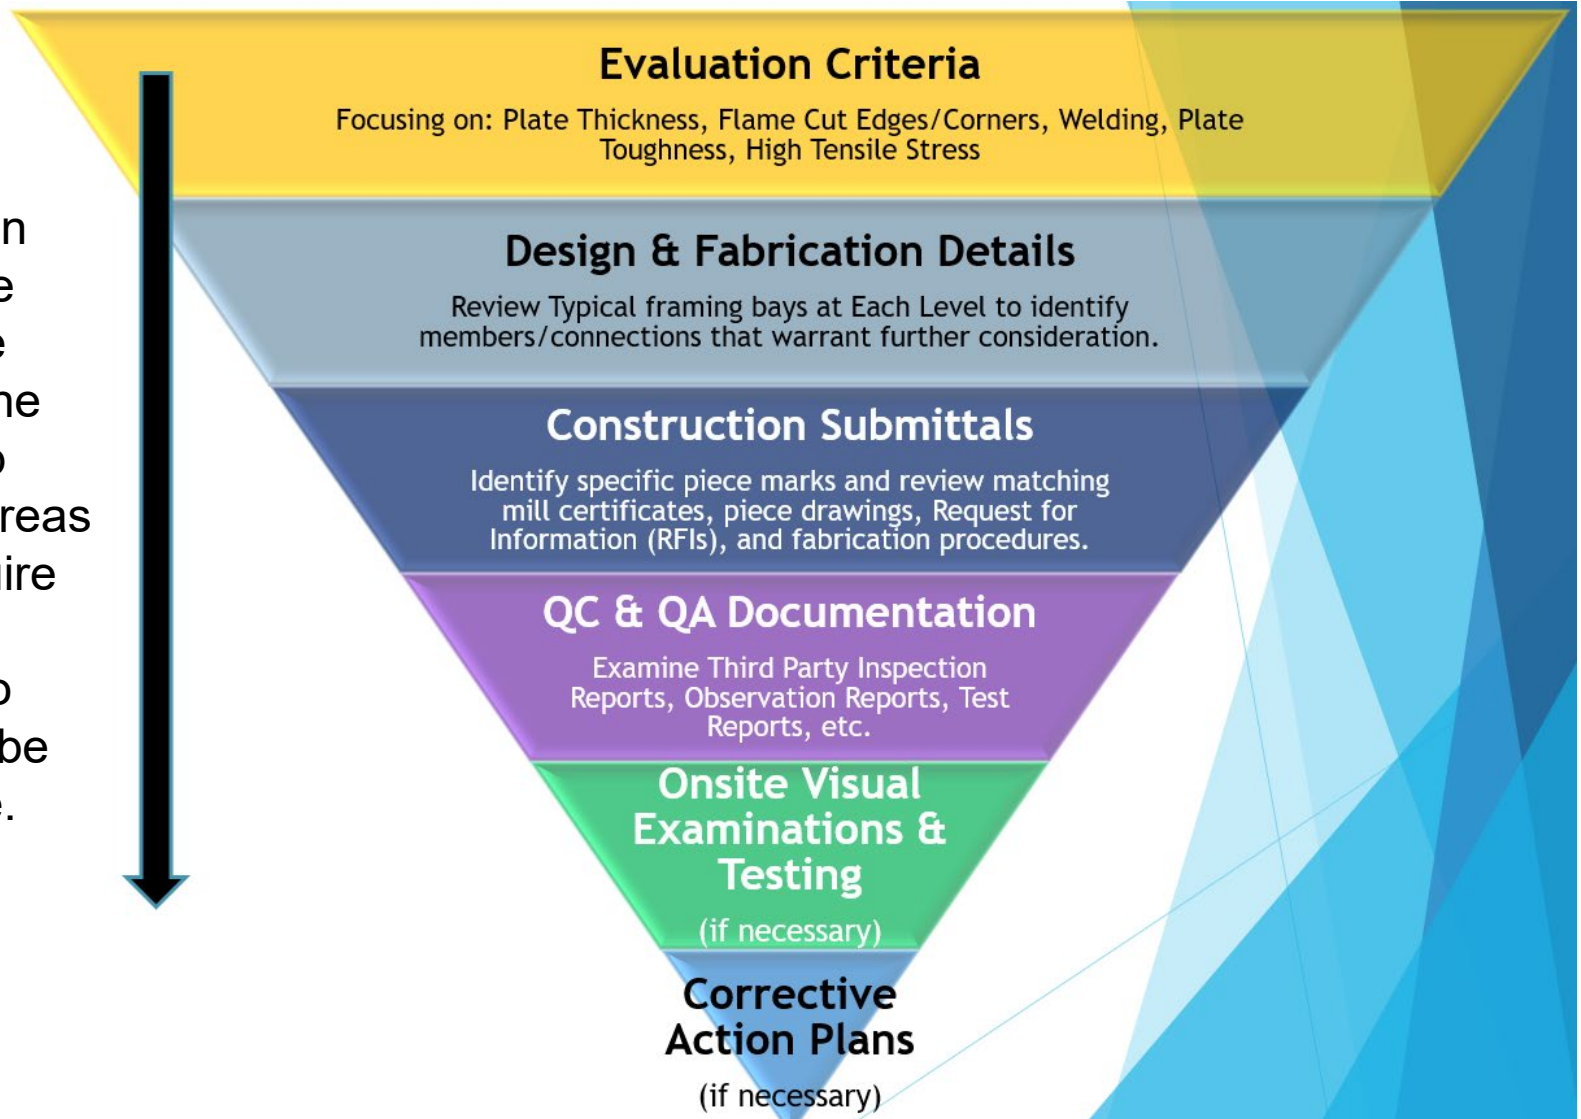
Full Building Structural Health Check

Progression through the successive sieves of the funnel help separate areas which require further research to confirm to be acceptable.
